Marsh Barton Station, Exeter

Devon County Council

Stage 1 Road Safety Audit

70070650/2283/RSA1/1/1

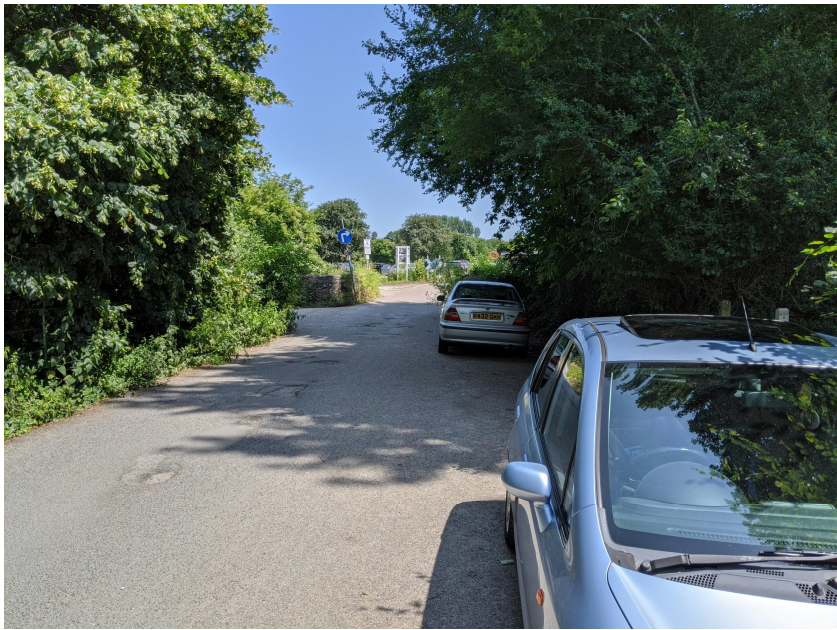
Location	Clapperbrook Lane East
Summary	Visibility to the right along Clapperbrook Lane East from the station access could be obstructed by parked vehicles.
Description	<p>During the site visit parked cars were observed on Clapperbrook Lane East to the east of the proposed station access, See Photograph 1.</p> <p>The visibility from the proposed access junction to vehicles approaching from the east could be restricted by parked vehicles to less than 10m. This could increase the possibility of a vehicle entering the Clapperbrook Lane East carriageway from the proposed access junction into the path of a vehicle travelling westbound, leading to a collision.</p>

<p>Photograph 1: the view eastbound along Clapperbrook Lane East to the east of the railway bridge</p>
Recommendation	It is recommended that parking is prohibited in this location to allow sufficient visibility between road users exiting the proposed station access and westbound vehicles on Clapperbrook Road.

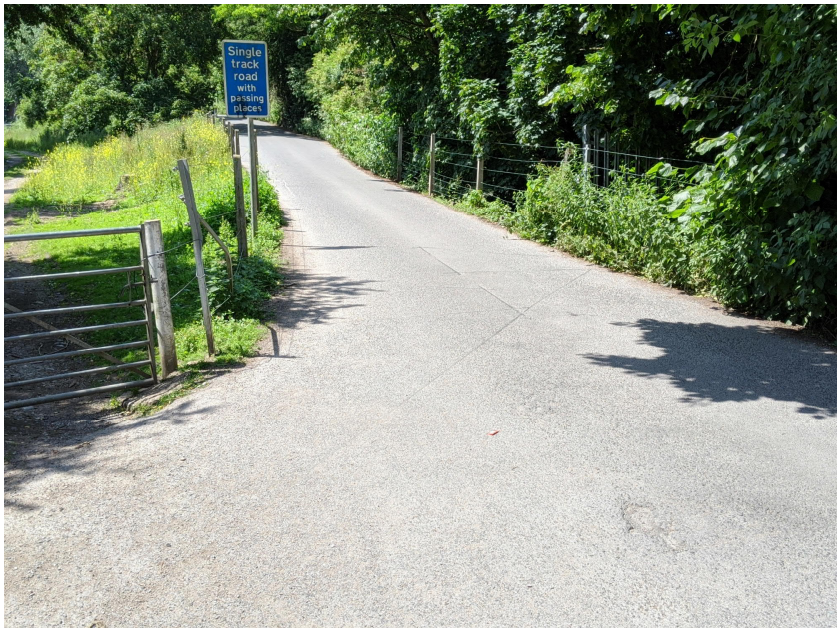
Location	Clapperbrook Lane East
Summary	Visibility to the left from the proposed station access could be obstructed by fences between the shared use footway / cycleway.
Description	<p>It is proposed to provide a fence between the existing Clapperbrook Lane East carriageway and proposed shared use footway / cycleway. No details have been provided regarding the type of fencing that will be used.</p> <p>The visibility from the proposed access junction to vehicles approaching from the west could be restricted by the fence to less than 15m (the existing visibility from the location of the proposed access is shown in Photograph 2). This could increase the possibility of a vehicle entering the Clapperbrook Lane East carriageway from the station access into the path of a vehicle, leading to a collision.</p>

<p>Photograph 2: the view westbound along Clapperbrook Lane East to the east of the railway bridge</p>

Recommendation	It is recommended the type and position of the fencing proposed makes allowance for the station access visibility requirements. Sufficient visibility between road users exiting the station access junction and eastbound vehicles on Clapperbrook Road must be provided.
